PROJECT STUDY REPORT EQUIVALENT

**San Pablo Ave Overhead
(Bridge # 28C0062)
Replacement Project
on San Pablo Avenue
just west of Hercules Ave**

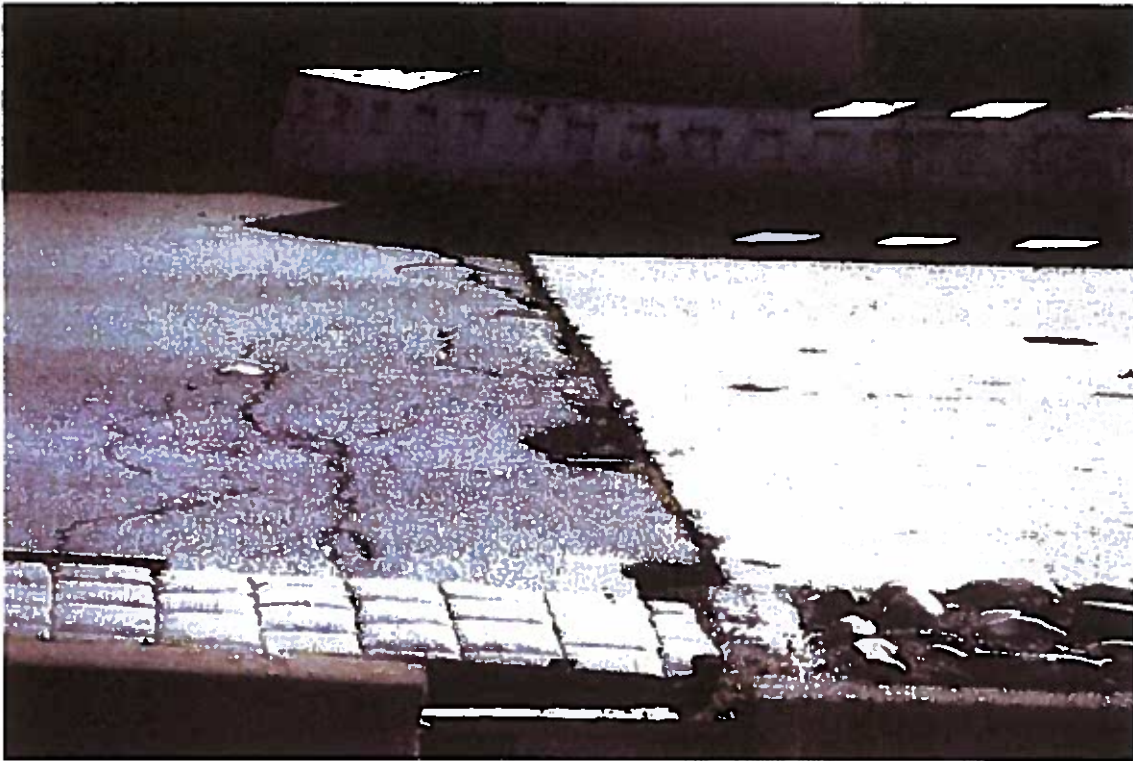
Photo No. 1

The AC approach in the eastbound lanes adjacent to Abutment 14 has a pothole of 1' X 6" X 2" (see attached photo No. 1). The AC approach in the westbound lanes adjacent to Abutment 14 has severe density cracks that are forming potholes (see attached photo No. 2).

1' X 6" X 2" AC approach pothole in the east bound lane at A 1.

There is a 12/15/2008 outstanding work recommendation to resurface this area of the AC approach pavement.

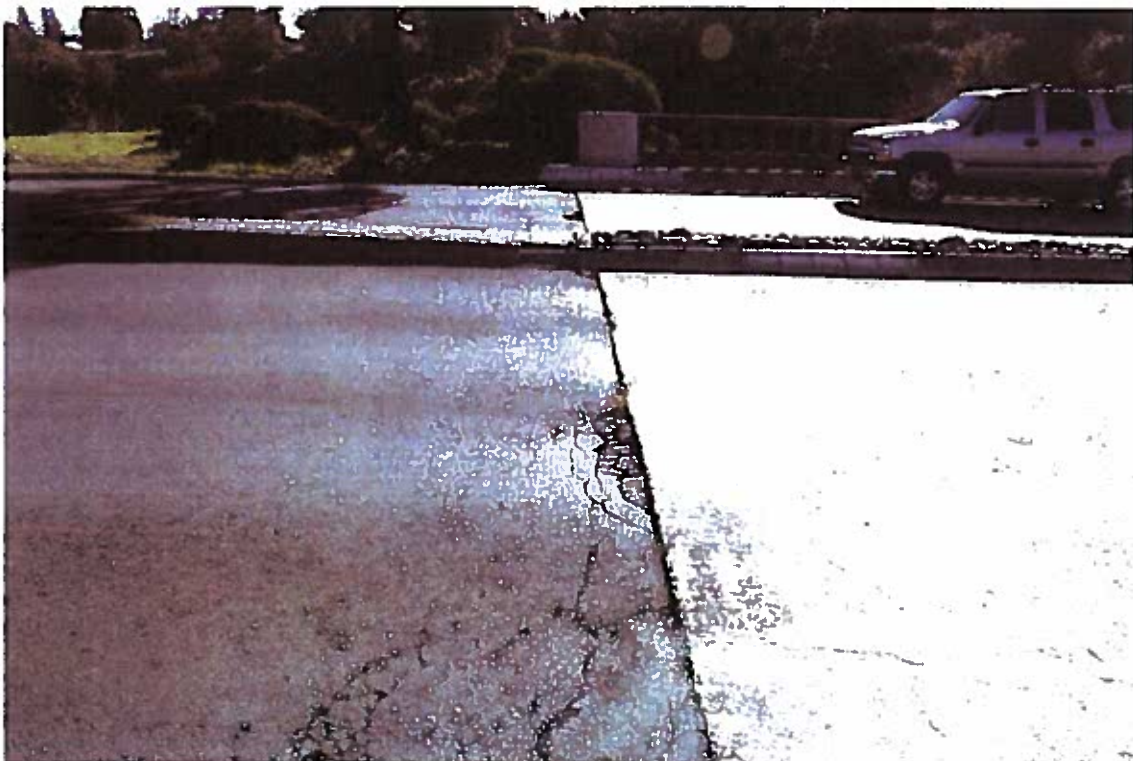
Photo No. 2

3" X 1' area of AC approach is cracking and potholing in the west bound lane at A 1.

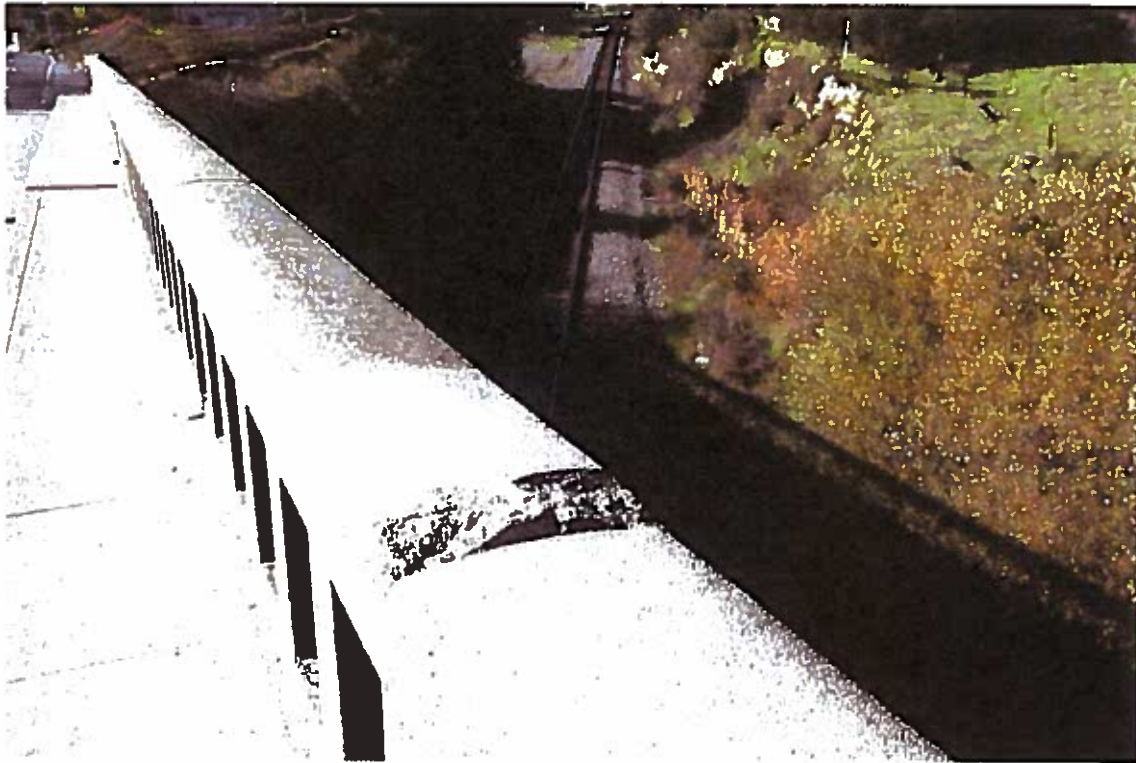
Photo No. 3

There is a spall in the top of the left RC rail (see attached photo No. 3).

Spall in the top of the right RC bridge rail.

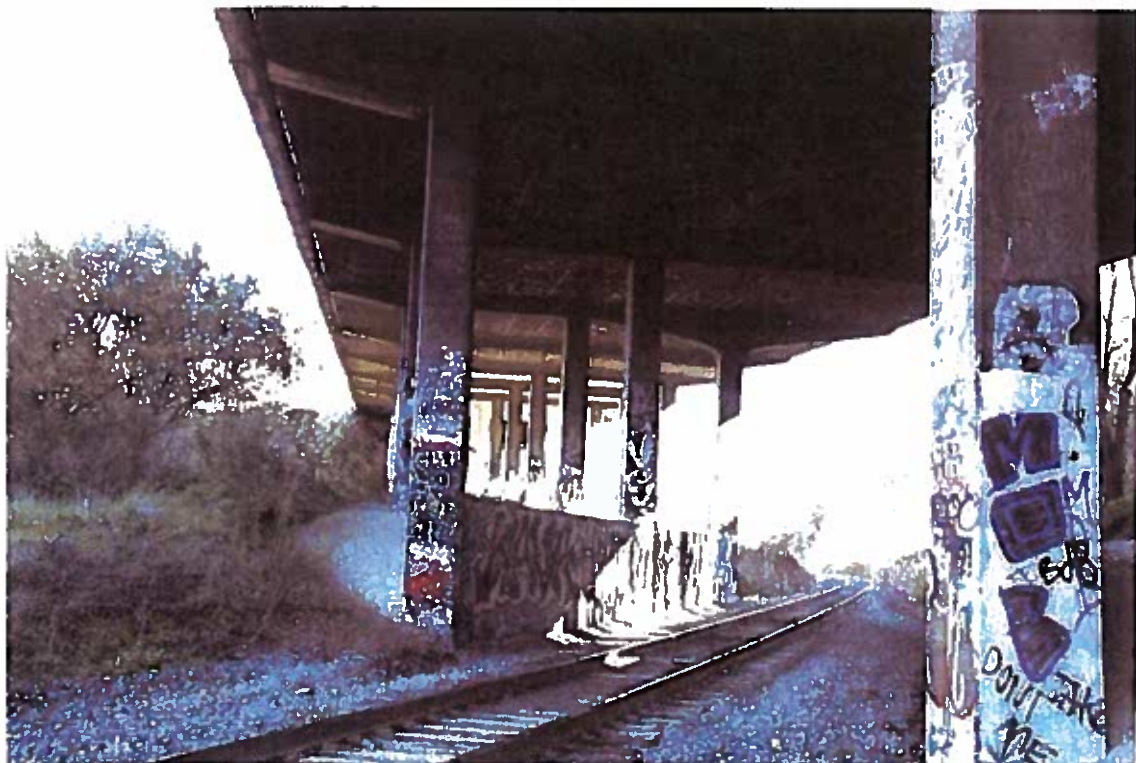
Photo No. 4

In addition to light efflorescence and some minor scaling on the soffit along the longitudinal construction joint near the centerline of the bridge, the following locations have cracks on the slab soffit:

SPAN	CONDITION
3	Longitudinal cracks with light efflorescence mainly on left half of span that are short to 2.4 meters (8 feet) long, spaced as close as 2 feet on center.
6	Longitudinal cracks with light efflorescence near Bent 7 that are short to 1 meter (3 feet) long and light in density.
8	Longitudinal crack with light efflorescence located 0.3 meters (1 foot) right of the centerline and 0.3 meters (1 foot) long.
9	Transverse cracks with light efflorescence that are up to 1 meter (3 feet) long and light in density seen near the centerline and the 3/4 span point.
11	Longitudinal cracks with light efflorescence that are short to 1 meter (3 feet) and light in density located near midspan.
13	Longitudinal cracks with light efflorescence that are moderate in density with a spacing as close as 1.2 meters (4 feet) on center.

Soffit details, looking towards A 1.

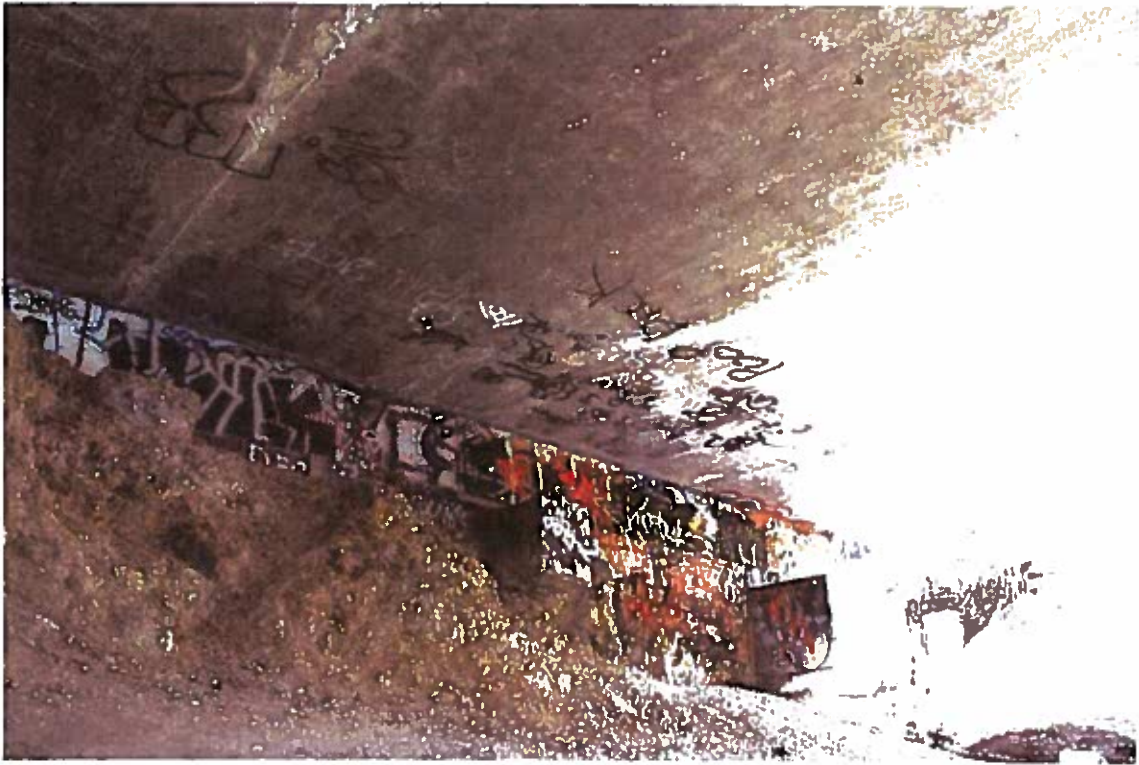
Photo No. 5

A portion of Abutment 14 is undermined up to 4 inches vertically and up to 4 feet horizontally below the footing for a 6 foot length along the face of the abutment. This undermining is due to erosion of the embankment which appears to have been caused by poor roadway drainage. The erosion extends for approximately one-third the length of the abutment from the right side (see attached photo No. 5).

Undermined Abutment 14 (right half) due to roadway run-offs.
